Property Inspection Report

Scott Kuster
Rigorous Inspections LLC

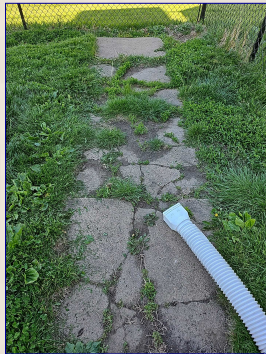
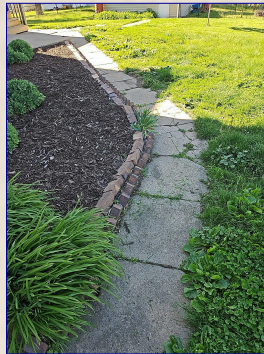
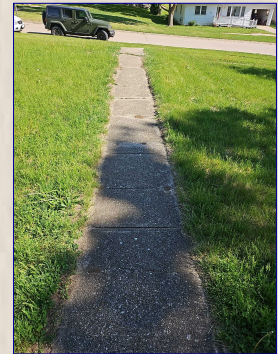
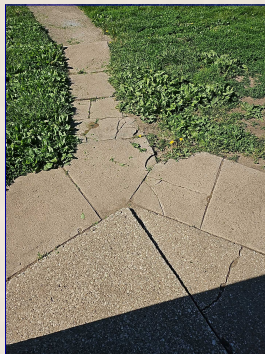
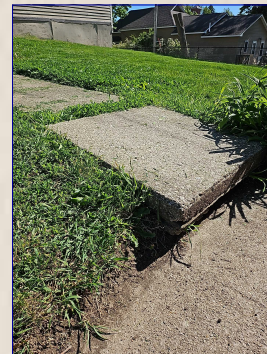
1. Service Walks

- Many of the concrete walkways had numerous cracks. Some were experiencing settlement and were slightly pitched.

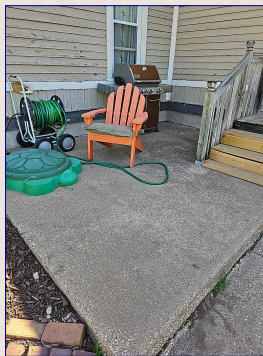
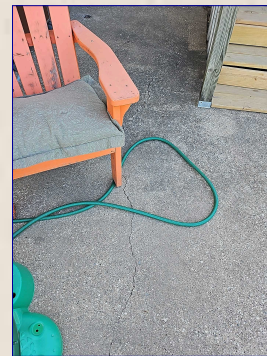
5. Patio

- The patio has typical cracks. Recommend a professional contractor seal the cracks to help protect the cement from damage.

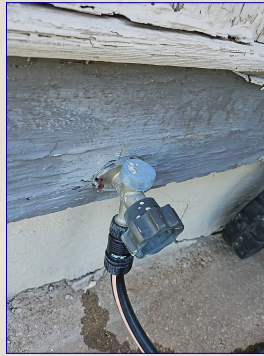
9. Hose Bibs

- Hose bib at the back patio was loose from the wall.

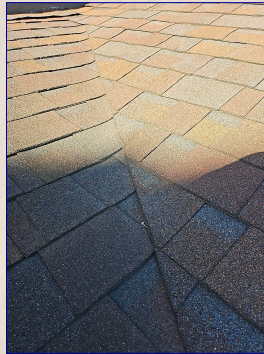
5. Flashing

• The flashing in the image with the blue arrow is not sealed at the top. Water could get behind the flashing. That section is located at the peak facing North. The style flashing in the image with the yellow arrow should be behind whatever wall cladding material is being used. Consider having a roofing contractor evaluate further.

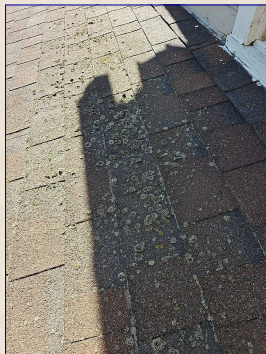
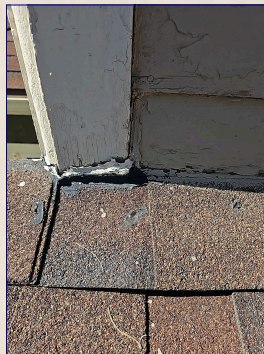
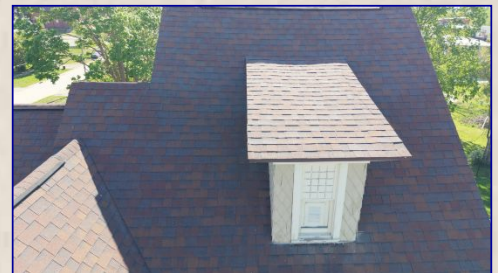
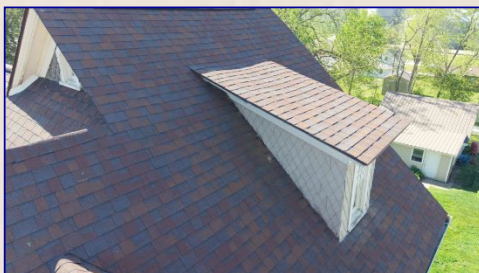
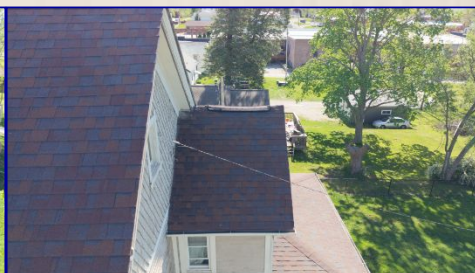
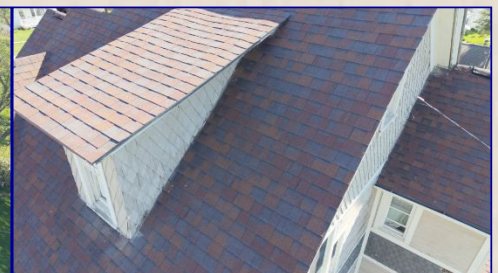
7. Condition of Roof Covering

- On the North side of the house the lower section of the roof has exposed nails at the final run against the house. I recommend having those nail heads resealed to prevent water intrusion. Recommend resealing areas where walls meet roof as well.

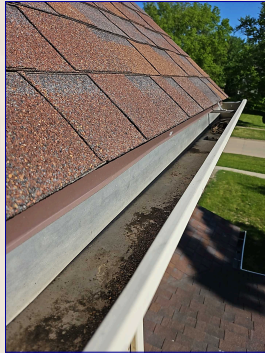
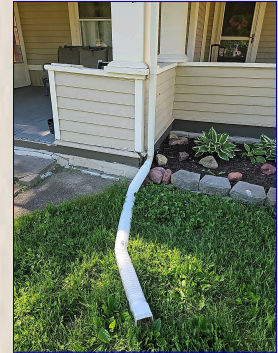
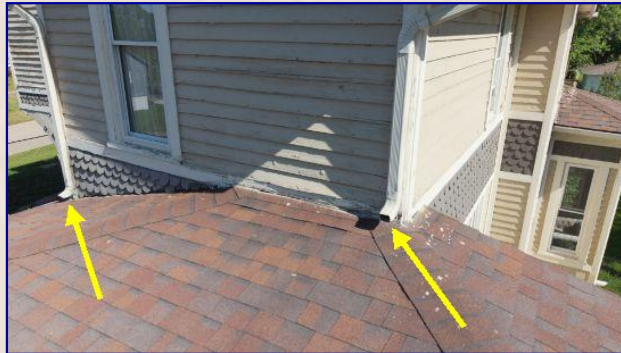
1. Gutters

- Consider having downspout extensions installed at all areas with a yellow arrow. Currently, the water coming through those gutters and downspouts dumps large amounts of water in one area which could cause premature wear on that section of shingle. The downspout extensions should run down to the next set of gutters.
- Proper downspout discharge extensions were observed around the home at ground level.

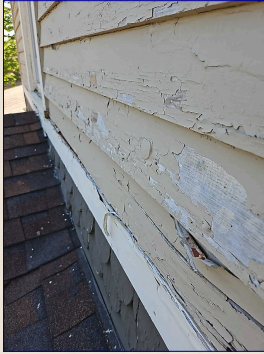
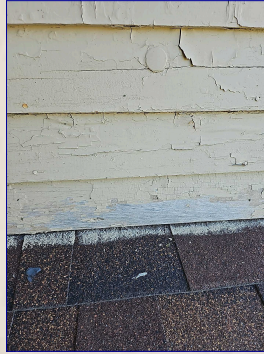
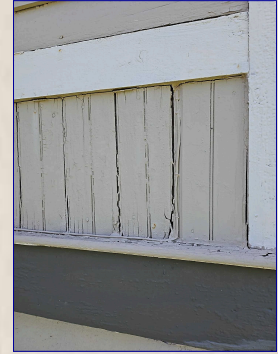
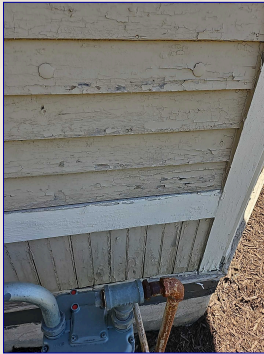
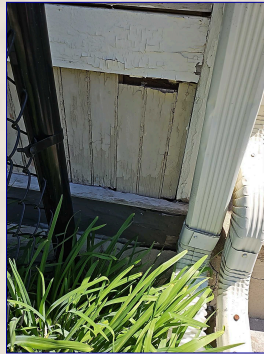
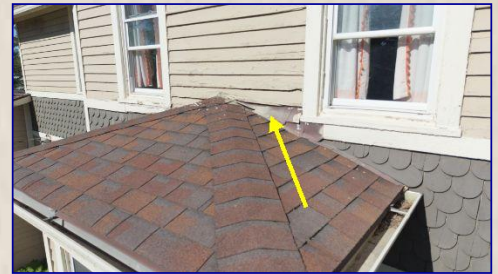
2. Siding

| Exterior | | |
|--|---|--|
| Page 13 Item: 2 | Siding | <ul style="list-style-type: none"> • Old wood siding/shake needs to be painted and some areas replaced. There was a section above one of the bump outs with a piece of siding missing. Someone installed several pieces of metal flashing in place of the missing siding. Consider contacting a siding contractor for further evaluation. |

- Old wood siding/shake needs to be painted and some areas replaced. There was a section above one of the bump outs with a piece of siding missing. Someone installed several pieces of metal flashing in place of the missing siding. Consider contacting a siding contractor for further evaluation.

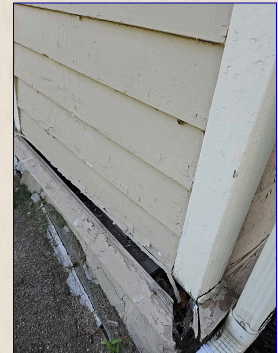
3. Trim

| Exterior | | |
|--|---|--|
| Page 14 Item: 3 | Trim | <ul style="list-style-type: none"> • There was a lot of damaged/deteriorated trim around the outside of this house. Many of the wood trim boards around the windows were deteriorating. With the condition of the siding and wood trim I recommend contacting a siding contractor for further evaluation. |

- There was a lot of damaged/deteriorated trim around the outside of this house. Many of the wood trim boards around the windows were deteriorating. With the condition of the siding and wood trim I recommend contacting a siding contractor for further evaluation.

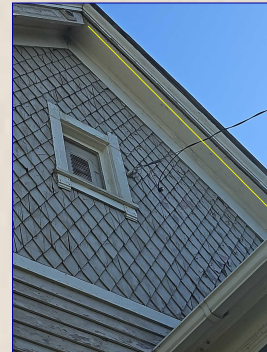
5. Fascia

Observations:
• Most of the fascia boards could use a maintenance coat of paint. Some fascia boards were starting to deteriorate. There was a missing fascia board on South gable, which is marked with a yellow line.

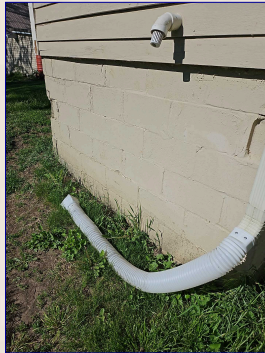
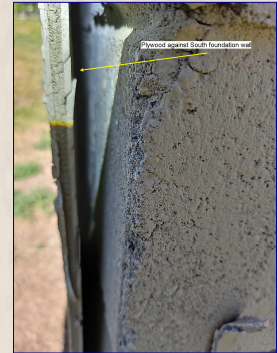
8. Foundation

- There were sheets of plywood attached to the South foundation wall. I could not see behind the plywood to determine the condition of this section of foundation wall.

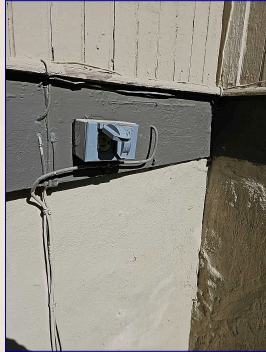
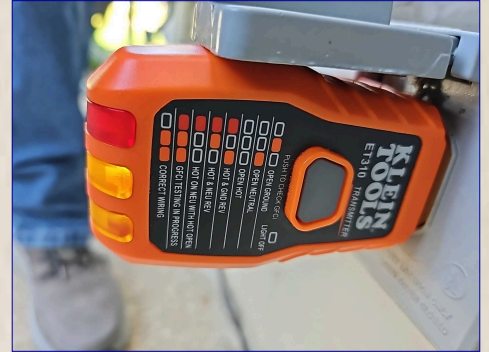
10. Exterior Receptacles

| Exterior | | |
|--|---|--|
| Page 17 Item: 10 | Exterior Receptacles | <ul style="list-style-type: none"> • Could not test exterior outlet on the East side of the house. The outlet covers wouldn't open far enough to get my tester plugged in. Also, this outlet box is loose from the wall. Exterior outlet on the West side of the house by the patio was wired properly but was not GFCI protected. |

- Could not test exterior outlet on the East side of the house. The outlet covers wouldn't open far enough to get my tester plugged in. Also, this outlet box is loose from the wall. Exterior outlet on the West side of the house by the patio was wired properly but was not GFCI protected.

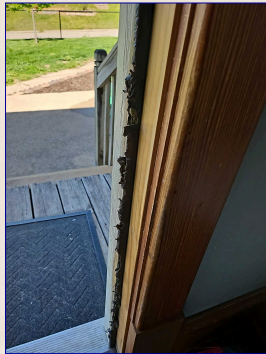
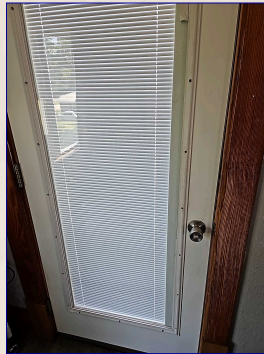
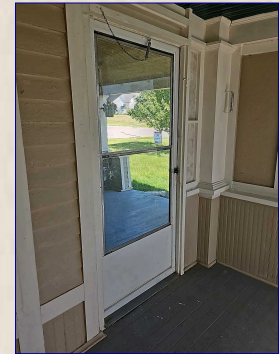
11. Exterior Doors

- Storm door in the sun room sticks at the top. Wooden front door is hard to open. Back door into the kitchen is in good condition but needs new weather stripping.
- Exterior door to the basement was locked.

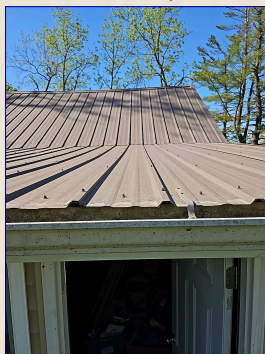
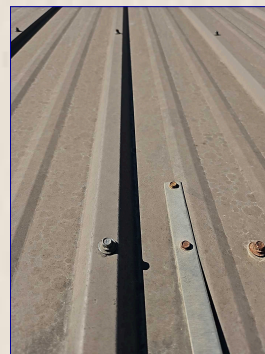
4. Roofing

- The metal on the garage roof appeared to have some age. Consider asking the homeowner when that metal roof was installed. The screws for metal roofs should generally be replaced every 10 - 15 years.

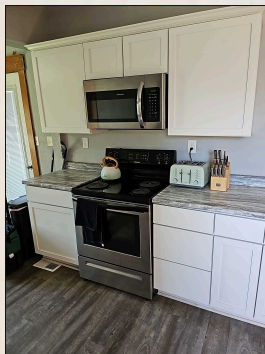
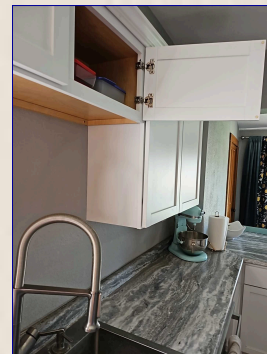
- Cabinet door above the sink had a loose hinge.

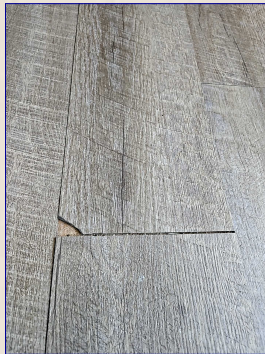
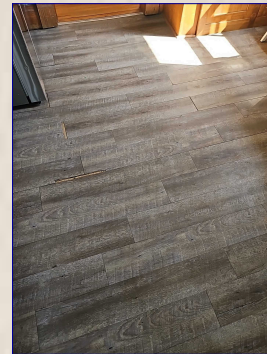
- Flooring installed is luxury vinyl plank(lvp). When lvp is installed it has high water resistance. However, this lvp was damaged and separating at many of the seams. In this condition water will slip between the cracks and potentially damaging the sub-floor. Recommend having the flooring replaced.

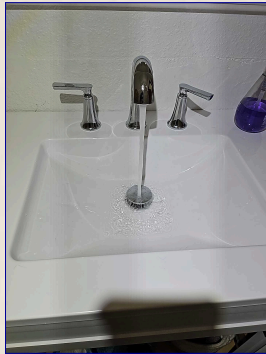
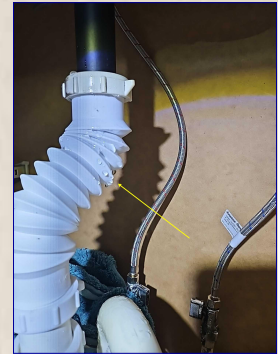
- Drain is leaking. Also, it is not recommended to use flex drain pipe for permanent sink drain plumbing. Consider contacting a plumber for further evaluation.

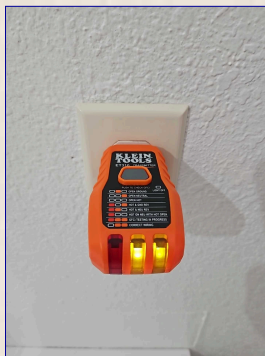
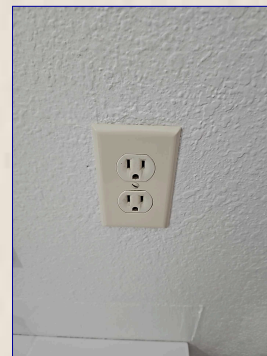
| Exterior | | |
|--|---|--|
| Page 39 Item: 8 | Receptacles | <ul style="list-style-type: none"> • A GFCI outlet should be installed in all wet/damp locations. Recommend further evaluation by a licensed electrical contractor. |

• A GFCI outlet should be installed in all wet/damp locations. Recommend further evaluation by a licensed electrical contractor.

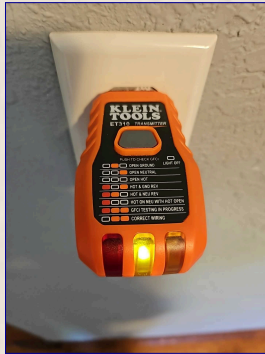
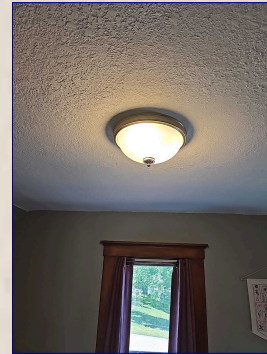
| Page 45 Item: 3 | Electrical | <ul style="list-style-type: none">• Open ground exists at the receptacles in the bedroom, which is a safety hazard. Recommend a licensed electrician repair. |

- Open ground exists at the receptacles in the bedroom, which is a safety hazard. Recommend a licensed electrician repair.

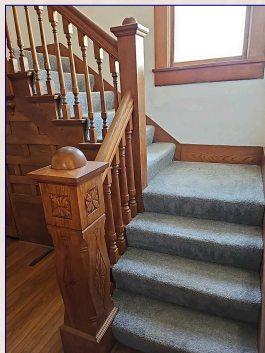
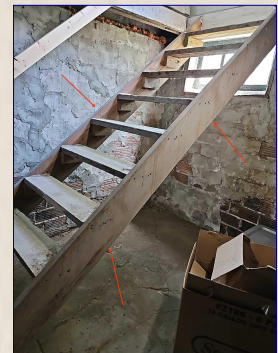
- The carpet at the first landing was worn in a couple spots.
- Stairs to the basement should be built with proper stringers for safety. See red arrow.

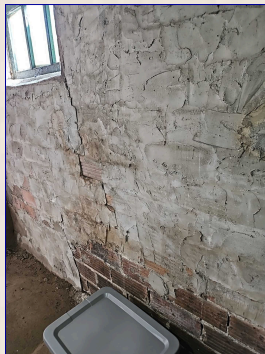
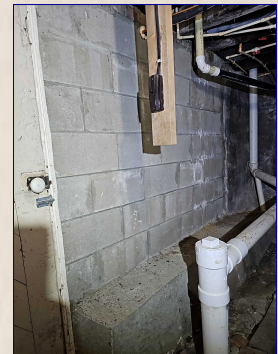
1. Foundation

- What foundation walls that could be seen looked good. Some walls appeared to have a skim coat of grout so those walls could not be properly observed.

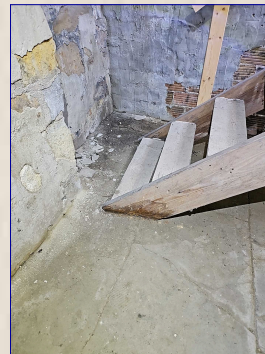
- The basement floor has expected cracks. Monitor and consult a licensed contractor if the cracks become active.
- Potential water intrusion into the basement at some point. The base of the basement stairs have moisture stains.

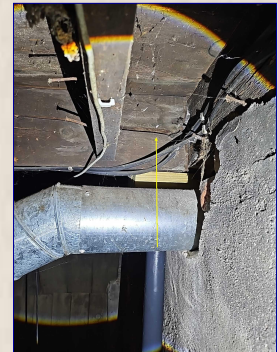
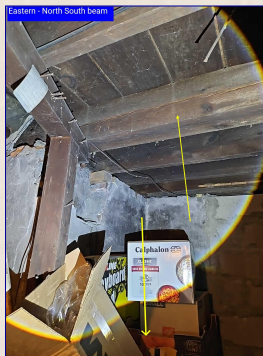
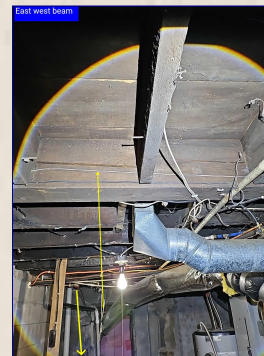
- Some of the beams had cracks. It is an older house but I would consider consulting with a framing contractor for further evaluation.

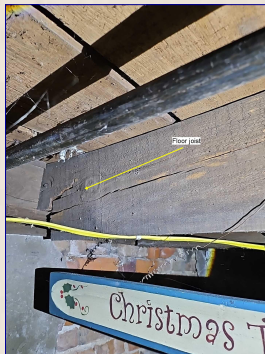
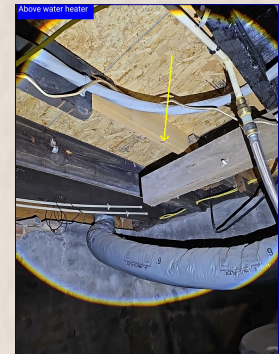
| Exterior | | |
|--|---|--|
| Page 53 Item: 7 | Joists | <ul style="list-style-type: none"> • There was a cracked floor joist in the west section of basement. In the main section of basement there were several burnt floor joists that have been piggybacked/sistered with new 2x6 boards for extra support. There was one joist above the water heater with a section cut out and replaced with a new piece of 2x6. I recommend consulting with a framing contractor for further evaluation. |

- There was a cracked floor joist in the west section of basement. In the main section of basement there were several burnt floor joists that have been piggybacked/sistered with new 2x6 boards for extra support. There was one joist above the water heater with a section cut out and replaced with a new piece of 2x6. I recommend consulting with a framing contractor for further evaluation.

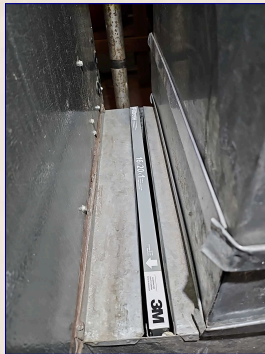
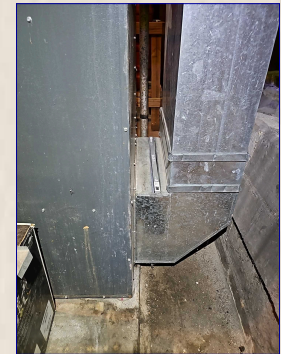
- While operating the furnace the filter got sucked in towards the fan. It was observed that only the North side had a track for the filter to slide into. This allows the South side of the filter to get pulled in.

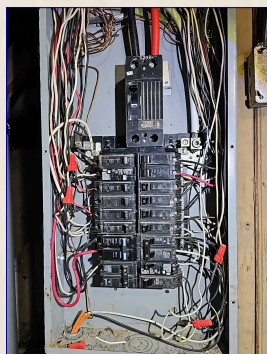
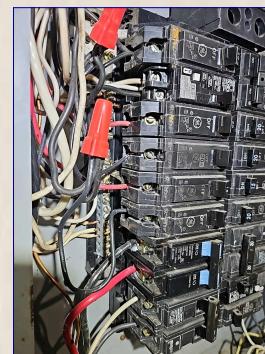
| Exterior | | |
|--|---|--|
| Page 61 Item: 5 | Branch Wire | <ul style="list-style-type: none"> • Some of the wire was non-metallic sheathed cable without a ground. Recommend budgeting to have those wires replaced. |

- Some of the wire was non-metallic sheathed cable without a ground. Recommend budgeting to have those wires replaced.
