Property Inspection Report

Scott Kuster
Rigorous Inspections LLC

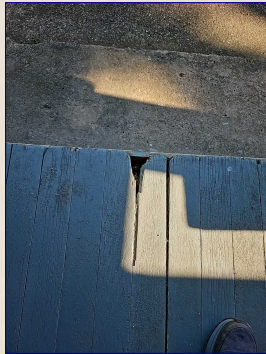
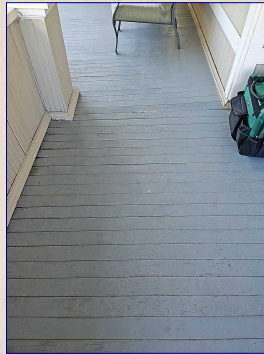
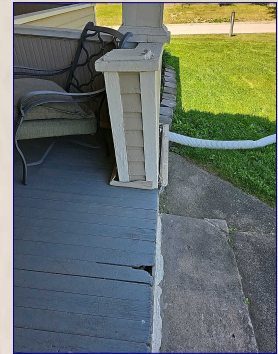
- The walking surface of the porch felt uneven. There may have been slight sagging in spots. The porch is in decent shape for how old the house is but will need attention in the future. The west partial wall is leaning slightly.

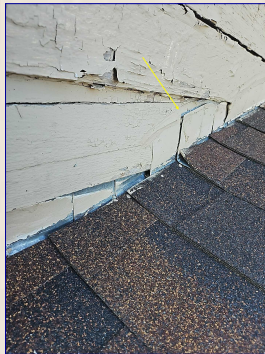
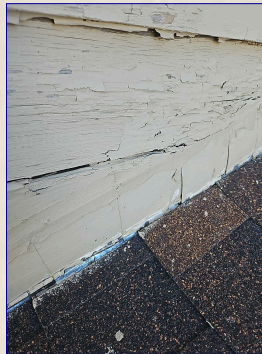
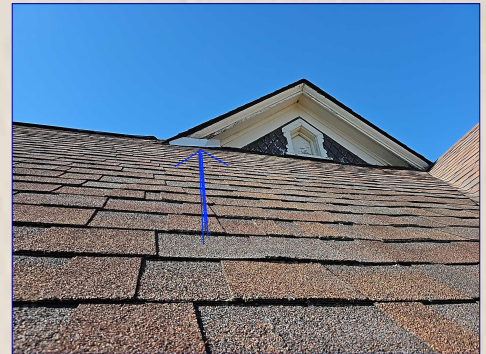
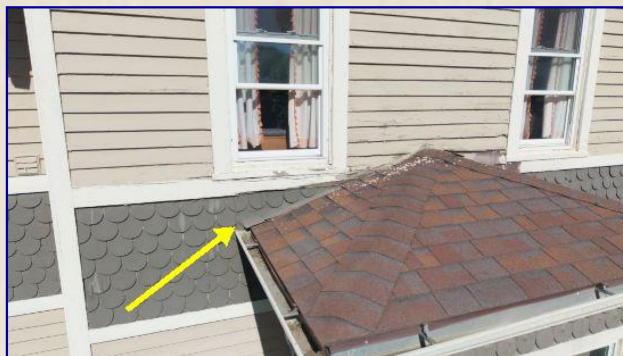
• The flashing in the image with the blue arrow is not sealed at the top. Water could get behind the flashing. That section is located at the peak facing North. The style flashing in the image with the yellow arrow should be behind whatever wall cladding material is being used. Consider having a roofing contractor evaluate further.

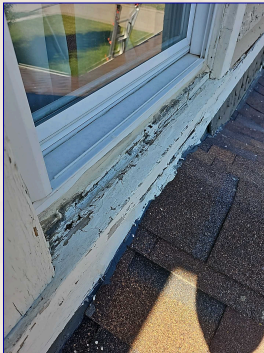
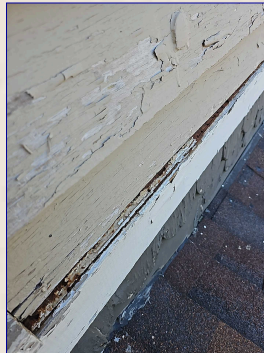
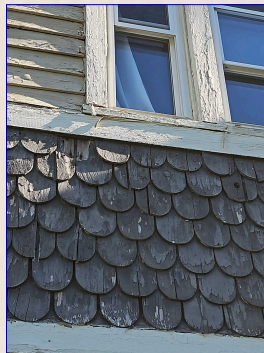
| Exterior | | |
|--|---|--|
| Page 14 Item: 3 | Trim | <ul style="list-style-type: none"> • There was a lot of damaged/deteriorated trim around the outside of this house. Many of the wood trim boards around the windows were deteriorating. With the condition of the siding and wood trim I recommend contacting a siding contractor for further evaluation. |

- There was a lot of damaged/deteriorated trim around the outside of this house. Many of the wood trim boards around the windows were deteriorating. With the condition of the siding and wood trim I recommend contacting a siding contractor for further evaluation.

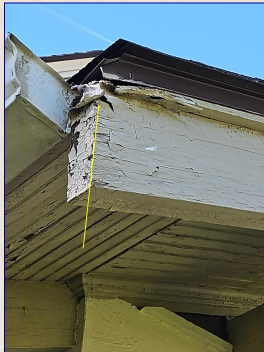
5. Fascia

Observations:
• Most of the fascia boards could use a maintenance coat of paint. Some fascia boards were starting to deteriorate. There was a missing fascia board on South gable, which is marked with a yellow line.

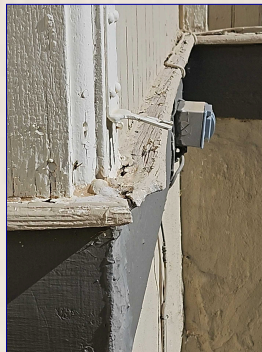
6. Caulking

Condition:
• Caulking dried/cracked

Observations:
• The caulking is dried and cracked. Recommend removing and replacing caulking around the exterior of the home. Where trim boards meet, around windows, and where there are utilities penetrating the wall.

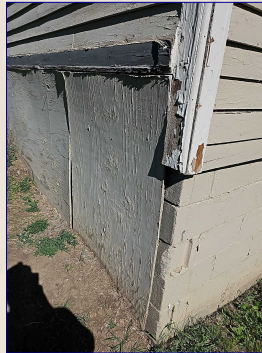
8. Foundation

- There were sheets of plywood attached to the South foundation wall. I could not see behind the plywood to determine the condition of this section of foundation wall.

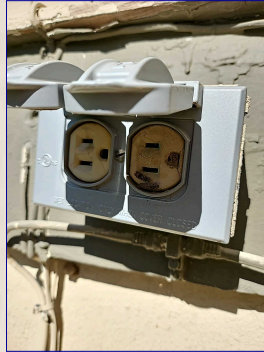
10. Exterior Receptacles

| Exterior | | |
|--|---|--|
| Page 17 Item: 10 | Exterior Receptacles | <ul style="list-style-type: none"> • Could not test exterior outlet on the East side of the house. The outlet covers wouldn't open far enough to get my tester plugged in. Also, this outlet box is loose from the wall. Exterior outlet on the West side of the house by the patio was wired properly but was not GFCI protected. |

- Could not test exterior outlet on the East side of the house. The outlet covers wouldn't open far enough to get my tester plugged in. Also, this outlet box is loose from the wall. Exterior outlet on the West side of the house by the patio was wired properly but was not GFCI protected.

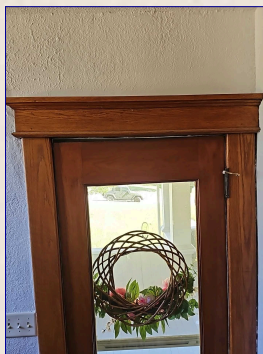
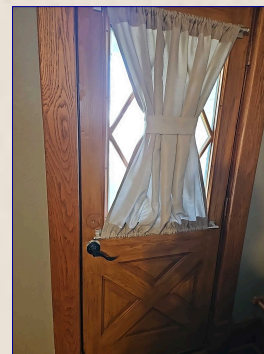
11. Exterior Doors

- Storm door in the sun room sticks at the top. Wooden front door is hard to open. Back door into the kitchen is in good condition but needs new weather stripping.
- Exterior door to the basement was locked.

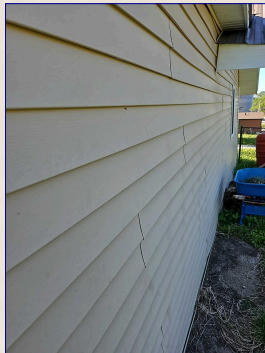
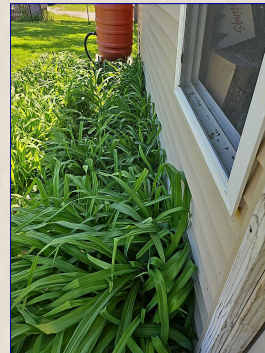
6. Siding

- Vegetation should be trimmed back away from the siding.

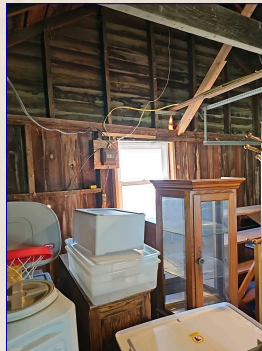
• Outlets in the garage were not inspected. There were too many personal belongings in the way. The outlet I could see did not appear to be a GFCI outlet.

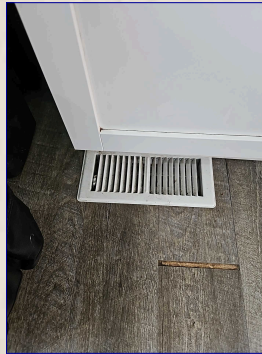
- Flooring installed is luxury vinyl plank(lvp). When lvp is installed it has high water resistance. However, this lvp was damaged and separating at many of the seams. In this condition water will slip between the cracks and potentially damaging the sub-floor. Recommend having the flooring replaced.

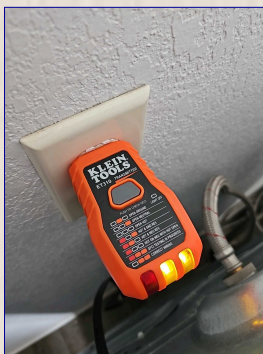
- There are missing GFCI receptacles in the laundry room, which is a safety concern. Recommend a licensed electrician install GFCI receptacles.

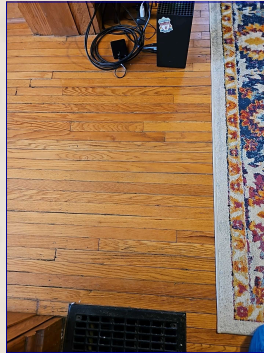
- Hardwood flooring had some minor sagging in spots.

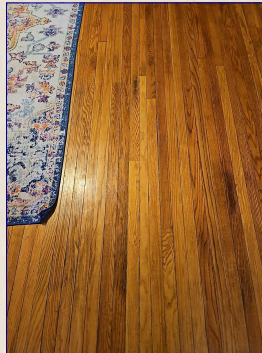
- Hardwood flooring had some minor sagging in spots.

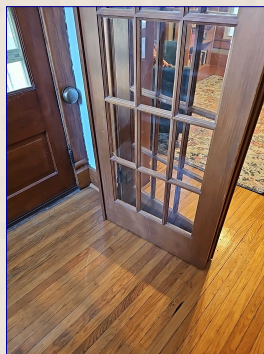
• Three panel folding door. Attempted to close the section that was folded and it rubbed the floor. A scuff on the floor can be seen where it has rubbed in the past.

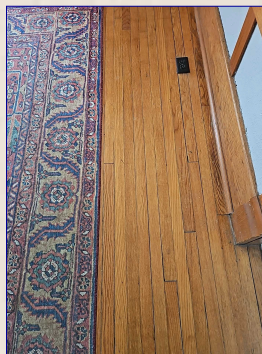
Observations:
 • Hardwood flooring had some minor sagging in spots.

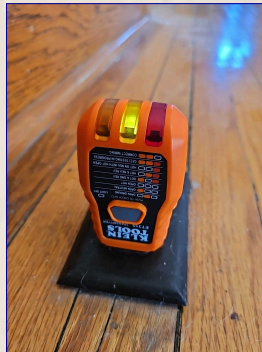
- Open ground exists at the receptacles in the room which is a safety hazard. Recommend a licensed electrician repair.

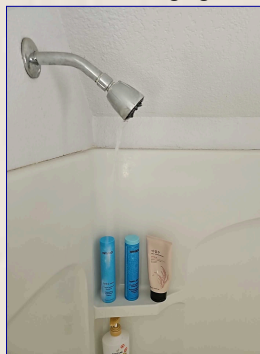
• Diverter valve that switches from the bathtub faucet to the shower head may need replaced. When the diverter was engaged only a trickle was observed from the shower head

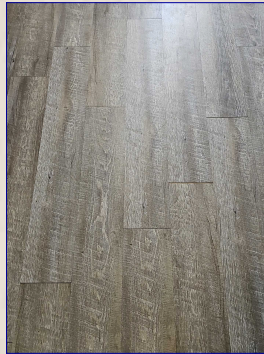
• Flooring installed is luxury vinyl plank(lvp). When lvp is installed it has high water resistance. However, this lvp was damaged and separating at many of the seams. In this condition water will slip between the cracks and potentially damaging the sub-floor. Recommend having the flooring replaced.

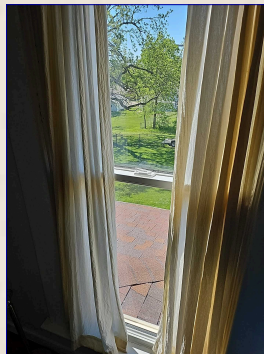
Window:
 • Missing/Damaged screens

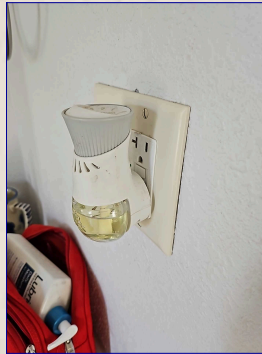
• Present: Yes
 • GFCI present: Yes
Observations:
 • Could not test GFCI outlet because the outlet was obstructed.

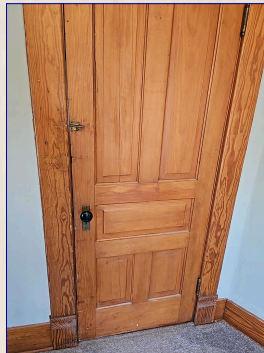
Observations:
 • Bedroom door does not latch.

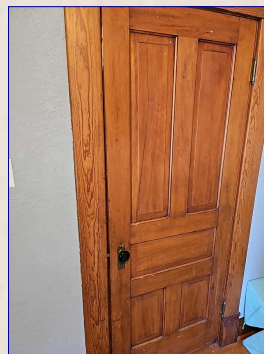
Observations:
• The door hits the frame and will not shut. Consider contacting a carpenter for adjustments/repair.

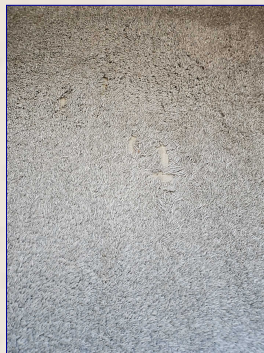
- The carpet at the first landing was worn in a couple spots.
- Stairs to the basement should be built with proper stringers for safety. See red arrow.

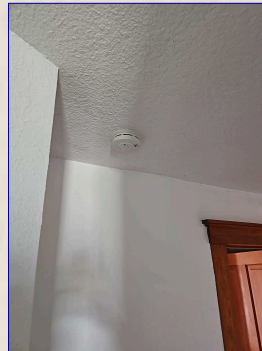
- There are missing carbon monoxide alarms noticed during the inspection, which is a safety hazard. Recommend installing carbon monoxide alarms per the manufacturer's specifications.

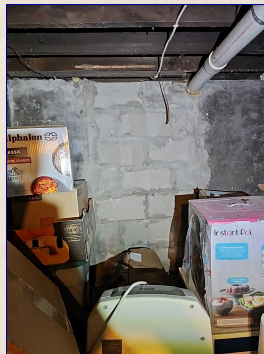
- What foundation walls that could be seen looked good. Some walls appeared to have a skim coat of grout so those walls could not be properly observed.

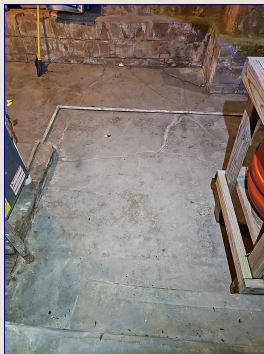
- The basement floor has expected cracks. Monitor and consult a licensed contractor if the cracks become active.
- Potential water intrusion into the basement at some point. The base of the basement stairs have moisture stains.

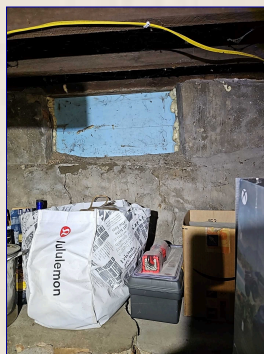
- Basement windows were boarded up.

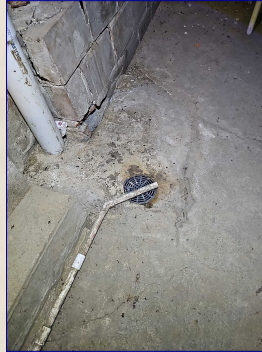
- The floor drain, as seen in the basement, was not tested. Recommend pouring water into the drain periodically to help prevent sewer gases from backing up into the home.

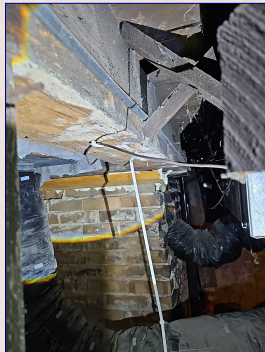
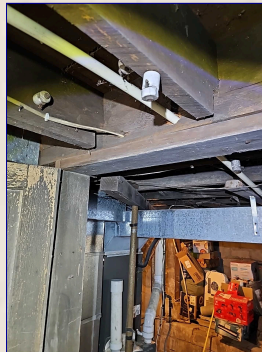
5. Girders/Beams

- Some of the beams had cracks. It is an older house but I would consider consulting with a framing contractor for further evaluation.

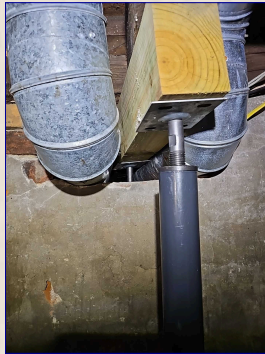
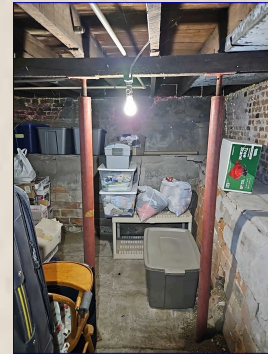
6. Columns

- Steel jack posts likely installed to help with joist sag due to the age of the house.

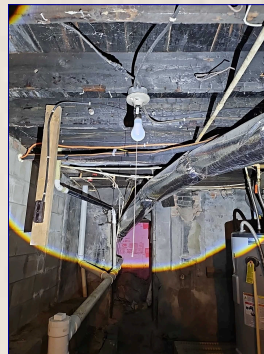
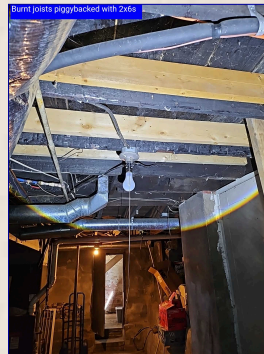
7. Joists

- There was a cracked floor joist in the west section of basement. In the main section of basement there were several burnt floor joists that have been piggybacked/sistered with new 2x6 boards for extra support. There was one joist above the water heater with a section cut out and replaced with a new piece of 2x6. I recommend consulting with a framing contractor for further evaluation.

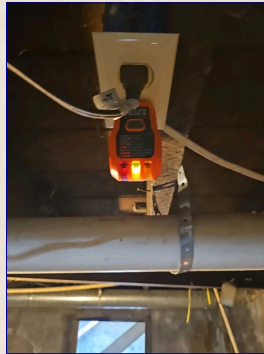
9. Electrical

- Open ground exists at the basement receptacles, which is a safety hazard. Recommend a licensed electrician repair.

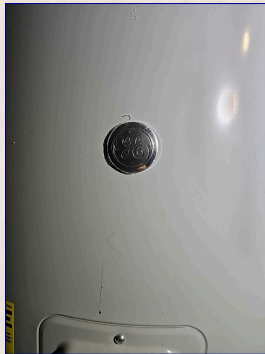
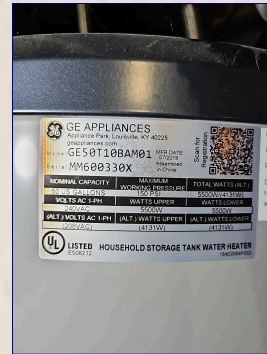
• This unit was manufactured in 2019. Water heaters in general have an average estimated useful service life of 10-12 years, though water quality, routine upkeep/maintenance, and location of the water heater will all play critical roles in the longevity of these systems.

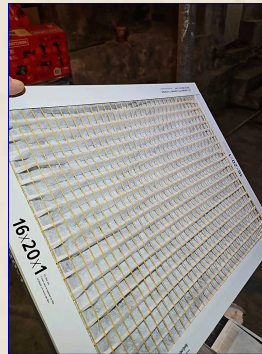
4. Filter/Operation/Other

- While operating the furnace the filter got sucked in towards the fan. It was observed that only the North side had a track for the filter to slide into. This allows the South side of the filter to get pulled in.

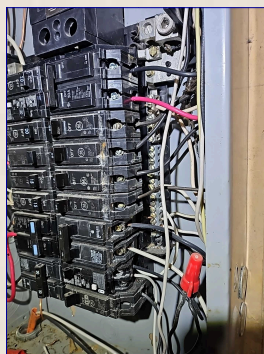
5. Branch Wire

- Some of the wire was non-metallic sheathed cable without a ground. Recommend budgeting to have those wires replaced.
